**DEPARTMENT OF TRANSPORTATION**

Contract #: 04-0120F4Cty: SF/ALA Rte: 80 PM: 13.2/13.9File #: 69.28**WELDING INSPECTION REPORT****Resident Engineer:**Pursell, Gary**Address:** 333 Burma Road**City:** Oakland, CA 94607**Report No:** WIR-002434**Date Inspected:** 15-May-2008**Project Name:** SAS Superstructure**OSM Arrival Time:** 2300**Prime Contractor:** American Bridge/Fluor Enterprises, a JV**OSM Departure Time:** 730**Contractor:** Zhenhua Port Machinery Company, Ltd (ZPMC), Changxing Island **Location:** Shanghai, China**CWI Name:****CWI Present:****Yes No****Inspected CWI report:** **Yes No N/A****Rod Oven in Use:** **Yes No N/A****Electrode to specification:** **Yes No N/A****Weld Procedures Followed:** **Yes No N/A****Qualified Welders:** **Yes No N/A****Verified Joint Fit-up:** **Yes No N/A****Approved Drawings:** **Yes No N/A****Approved WPS:** **Yes No N/A****Delayed / Cancelled:** **Yes No N/A****Bridge No:** 34-0006**Component:** OBG**Summary of Items Observed:**

## WELDING INSPECTION REPORT

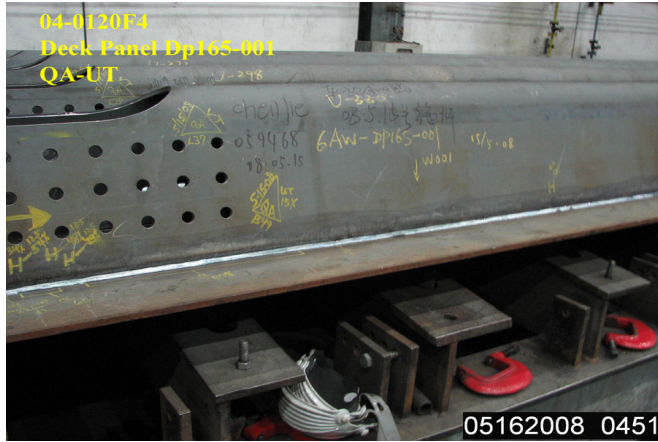
New OBG Bay 1: Caltrans QA Inspector performed an Ultrasonic Test (UT) inspection of the partial joint penetration (PJP) weld joining the closed u-rib to the deck panel. The deck panel assemblies are identified as DP435-001, DP383-001, DP381-001, DP165-001 and DP549-002. Caltrans QA Inspector recorded the results of the inspection and generated an ultrasonic test report. See Caltrans Ultrasonic Testing Report (TL-6027 Modified), dated May, 15, 2008 for additional information. The following digital picture illustrates deck panel DP165-001.
